# **Children's Play Area Annual Inspection Reports**

**GRAVESHAM BOROUGH  
COUNCIL**

**MARIA COOK RPii**

**Site:** **Judson's Recreation Ground**

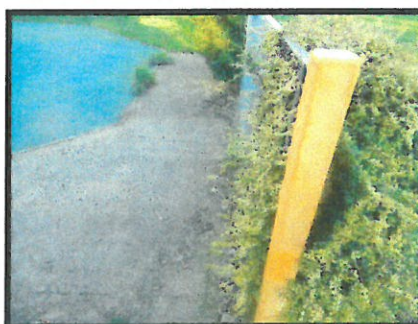
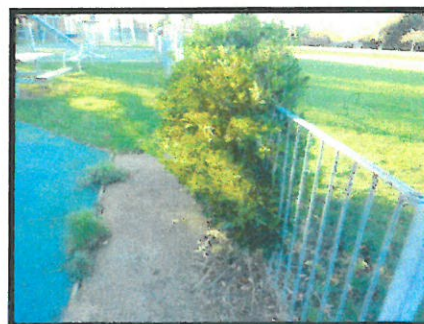
## Planting

The bushes around the gate require cutting back. *Low Risk*

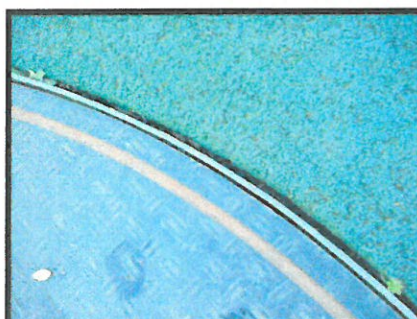
1. The surfacing is lifting at the edge of the roundabout. **Monitor**

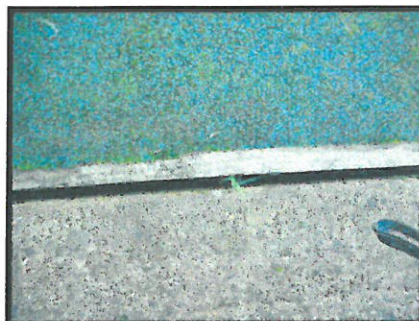
2. The timber edging is shrinking from the concrete path edge.  
**Monitor**

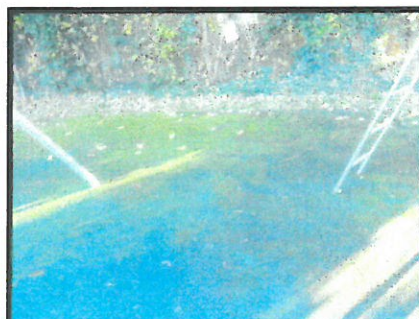
1. There is algae growth on the surface giving slippery conditions.  
***It is recommended that the surface is cleaned and treated with an appropriate non-toxic weed killer. Moderate Risk***

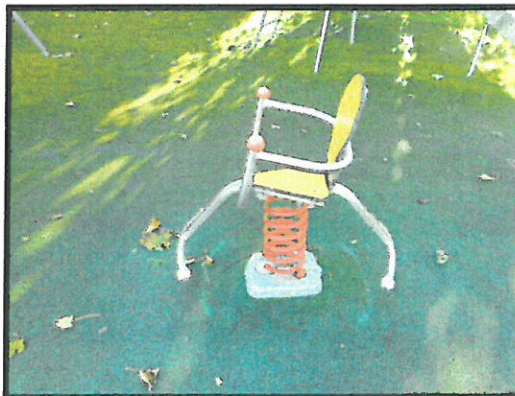
## Spring Seat

1. There is movement to the base fixing of the spring. **Refix to secure. Low Risk**

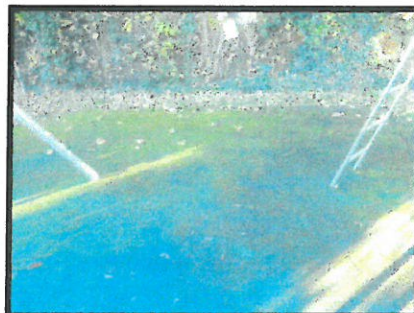
1. There is algae growth on the surface giving slippery conditions. *It is recommended that the surface is cleaned and treated with an appropriate non-toxic weed killer.* **Moderate Risk**

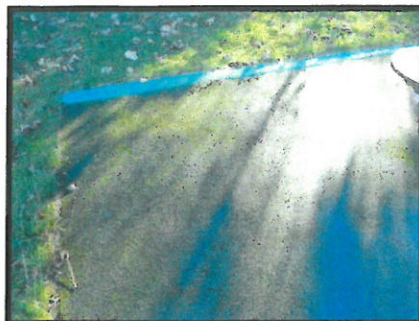
1. There is algae growth on the surface giving slippery conditions. *It is recommended that the surface is cleaned and treated with an appropriate non-toxic weed killer. Moderate Risk*

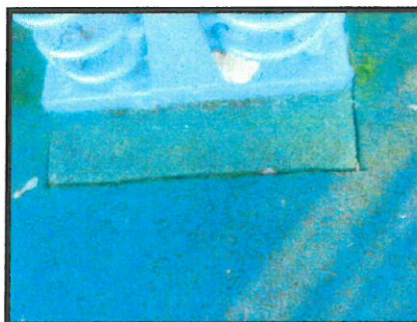
2. There is shrinkage around the centre repair. *Monitor*

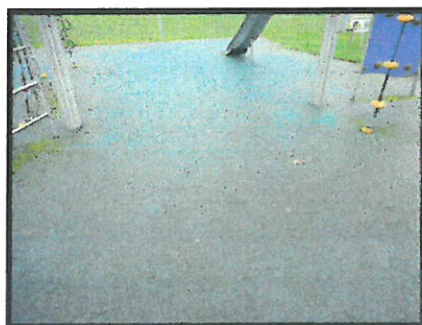
1. The surfacing area is marginally insufficient at the climbing wall. This is considered to be **low risk**.

1. There is algae growth on the surface giving slippery conditions. ***It is recommended that the surface is cleaned and treated with an appropriate non-toxic weed killer.*** **Moderate Risk**

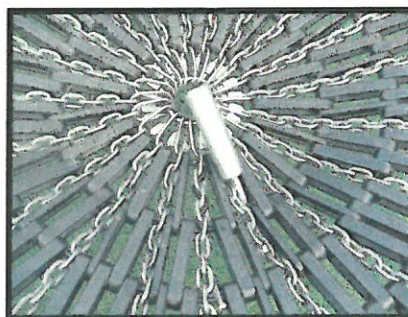
1. Technically, there is a finger entrapment to the plastic fixings to the basket seat. This is however, considered to be **low risk**.

**Note:** A risk assessment based on previous accidents indicates a safety chain is required to each chain set to the basket seat.

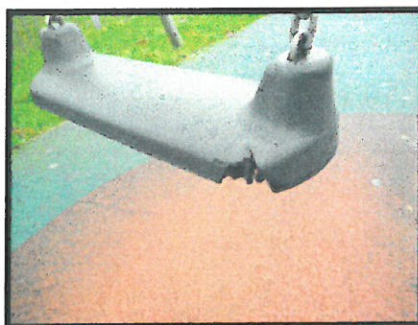
1. There is minor damage and splitting to one flat seat. **Monitor**

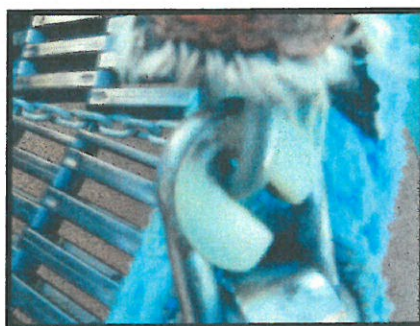
2. There is fraying to the chain covers to the basket. **It is recommended that the plastic cover is cut back and fraying removed.**
3. There is some chain wear. **Monitor and replace at 40% wear.**
4. There is wear to the plastic washer to the basket fixings. **Replacement is recommended.**

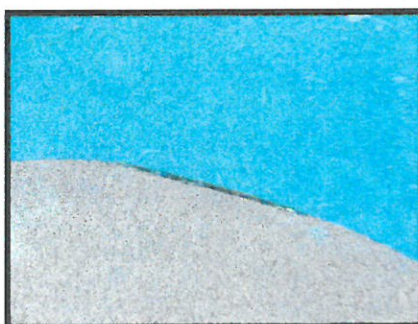
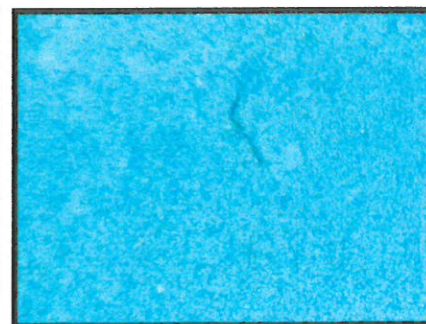
1. There is separation and some cracking to the coloured areas. **Monitor** **Low Risk**

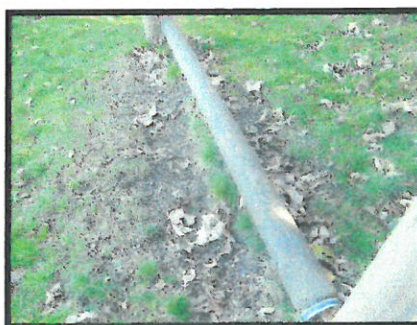
1. There is erosion to the sides of the wobble log. **Reinstatement is recommended.** **Low Risk**
