# **Children's Play Area Annual Inspection Reports**

**GRAVESHAM BOROUGH  
COUNCIL**

**MARIA COOK RPii**

**Site:** **Judson's Recreation Ground**

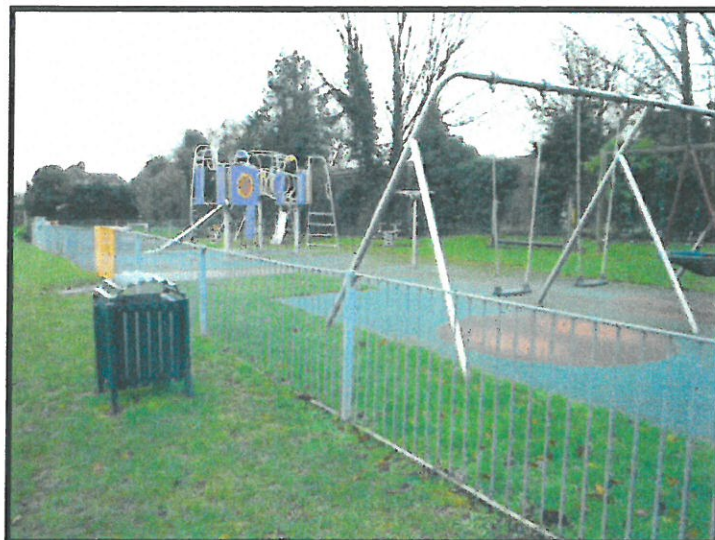
The play area is in good condition. The safer surfacing areas require cleaning to remove algae and to reduce the risk of slipping.

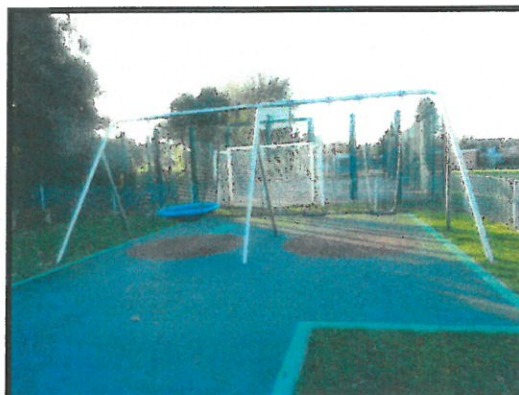
## 2 Bays, 2 Flat seats with antiwraps & 1 Basket seat

**BS EN 1176 Compliance:** No

1. Technically, there is a finger entrapment to the plastic fixings to the basket seat. This is however, considered to be **low risk**.

**Note:** It was not possible to check all the lower chains for wear, as only one cover pulls back.
